ARBORICULTURAL IMPACT ASSESSMENT (AIA)

JULY 2024

Hogshaw Farm

Project No.:	UG1795			
Project:	Hogshaw Farm			
Location:	Hogshaw Farm, Fairfield, Buxton, SK17 7HN			
Title:	Arboricultural Impact Assessment			
Document Type:	BS 5837: 2012			
Date:	17/03/2023			
Prepared By:	Adam Hodgins			
Checked By:	Robert Hickey			
Approved By:	Gemma King			
Revision Status:				
Rev:	Date:	Issue/Purpose/ Comment:	Prepared:	Checked:
01	17/03/2023	Updated layout	AH	AB
02	22/03/2023	Updated layout	AH	AB
03	05/04/2023	Updated layout	AH	AB
04	14/02/2024	Updated layout	HL	AH
05	06/03/2024	Updated layout	HL	AB
06	12/03/2024	Updated layout	HL	AB
07	08/07/2024	Updated layout	HL	AH

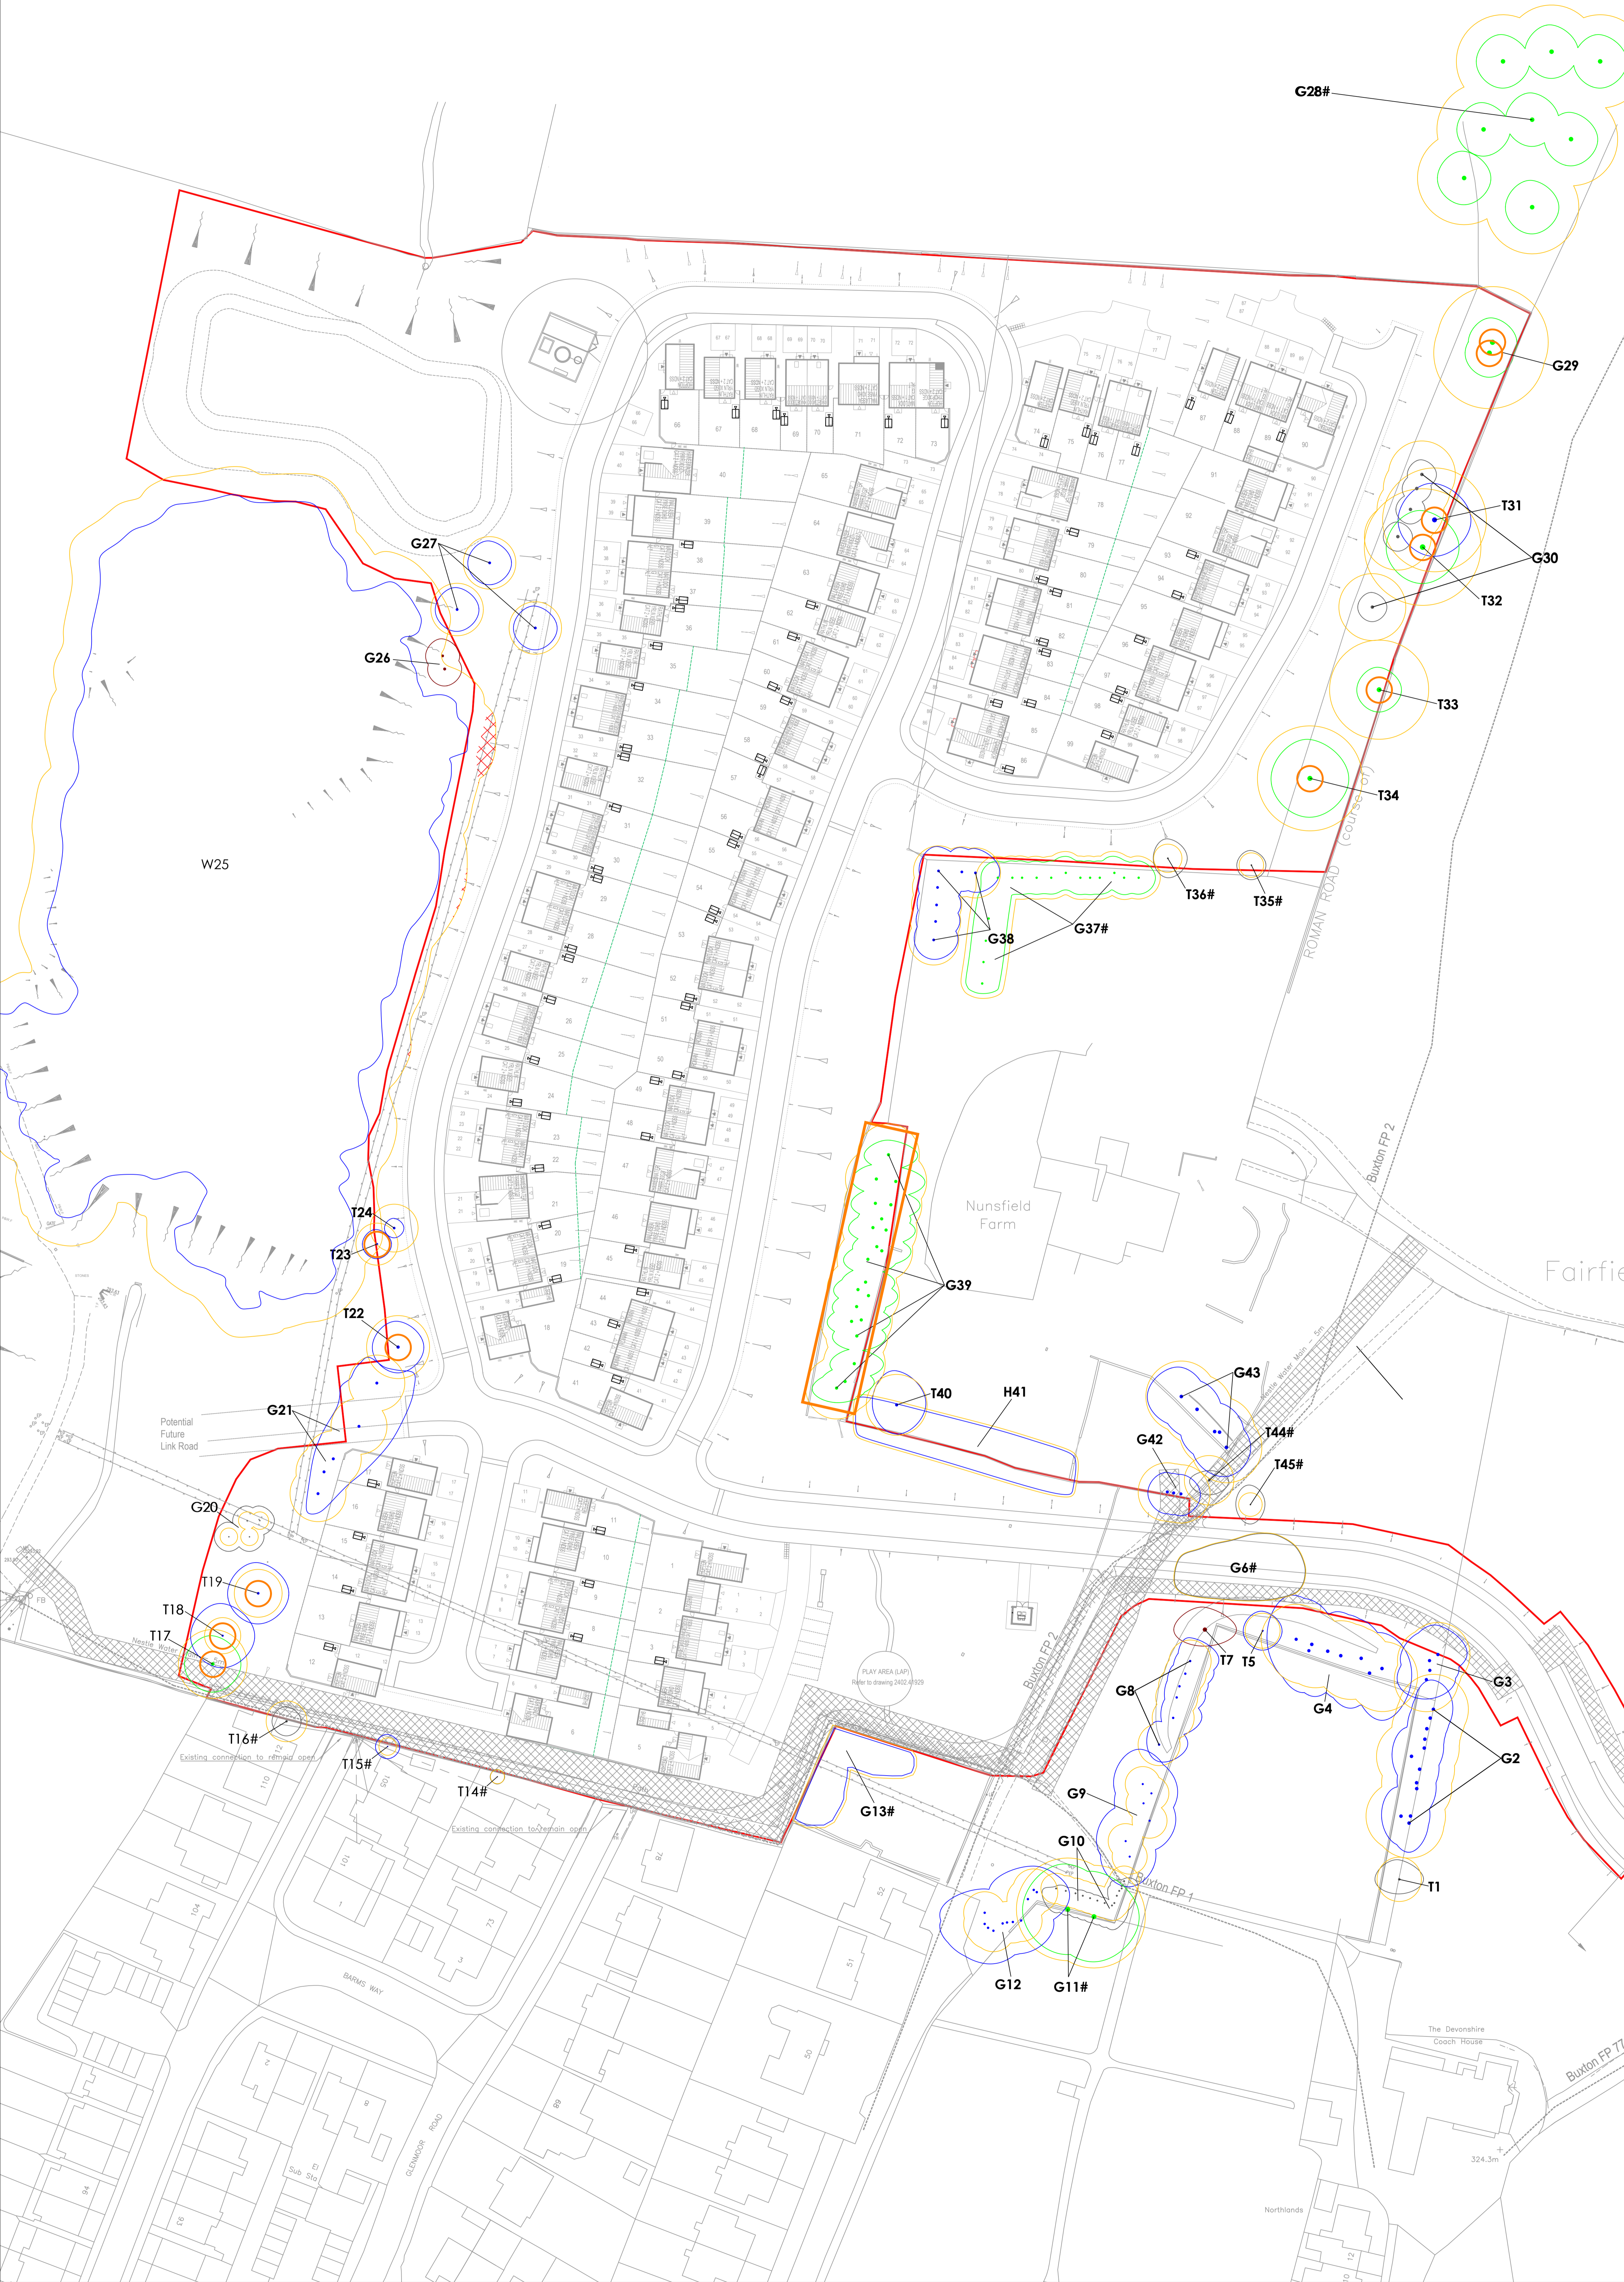
Client:	Project:	Drawn:	Checked:	Approved:	Date:
BARRATT HOMES MANCHESTER	HOGSHAW FARM, FAIRFIELD, BUXTON	AH	RH	GK	24/01/23
Issue:	Title:	Dwg No:	Scale @ A0:	Revision:	
PLANNING	TREE REMOVAL PLAN	UG_1795_ARB_TRP_01	1:500	05

- 1.1.3. The proposed development necessitates the removal of Two individual trees, three tree groups and two trees from a further tree group. All tree removals are within the site boundary except two trees which are on or just outside the site boundary. One tree group to be removed is low value natural colonisation internal to the site. There are several moderate quality trees and one moderate quality tree group which will be removed to accommodate the development which will have only minor impacts on the wider amenity, their loss should be alleviated by replacement tree planting and the production of a robust soft landscaping scheme.

- 4.5.4. One tree, T7, and one tree group, G26, were assessed as 'Unsuitable' BS 5837: 2012 Retention Category 'U' and will require removal irrespective of the proposed development, in line with good Arboricultural practice. However, as these trees are offsite and under third-party ownership, the landowner will need to be made aware of their condition and need for removal.

G6	C	Willow sp.	Fell to ground level, grind or grub out stumps and remove Himalayan balsam.						
T7	U	Goat willow	Inform landowner of condition and need for removal.	Arboricultural best practice.					
G21	B	Mixed sp. (Silver birch, Wild cherry)	Fell to ground level and grind or grub out stumps.	To facilitate the development.					
T22	B	Lime							
T24	B	Silver birch							
G26	U	Elder	Inform landowner of condition and need for removal.	Arboricultural best practice.					
G27	B	Goat willow	Fell to ground level and grind or grub out stumps.	To facilitate the development.					
G42	B	Leyland Cypress	Lightly prune southern side of canopy to facilitate construction of northern batter.	To facilitate the development.					
G45	C	Willow Sp.

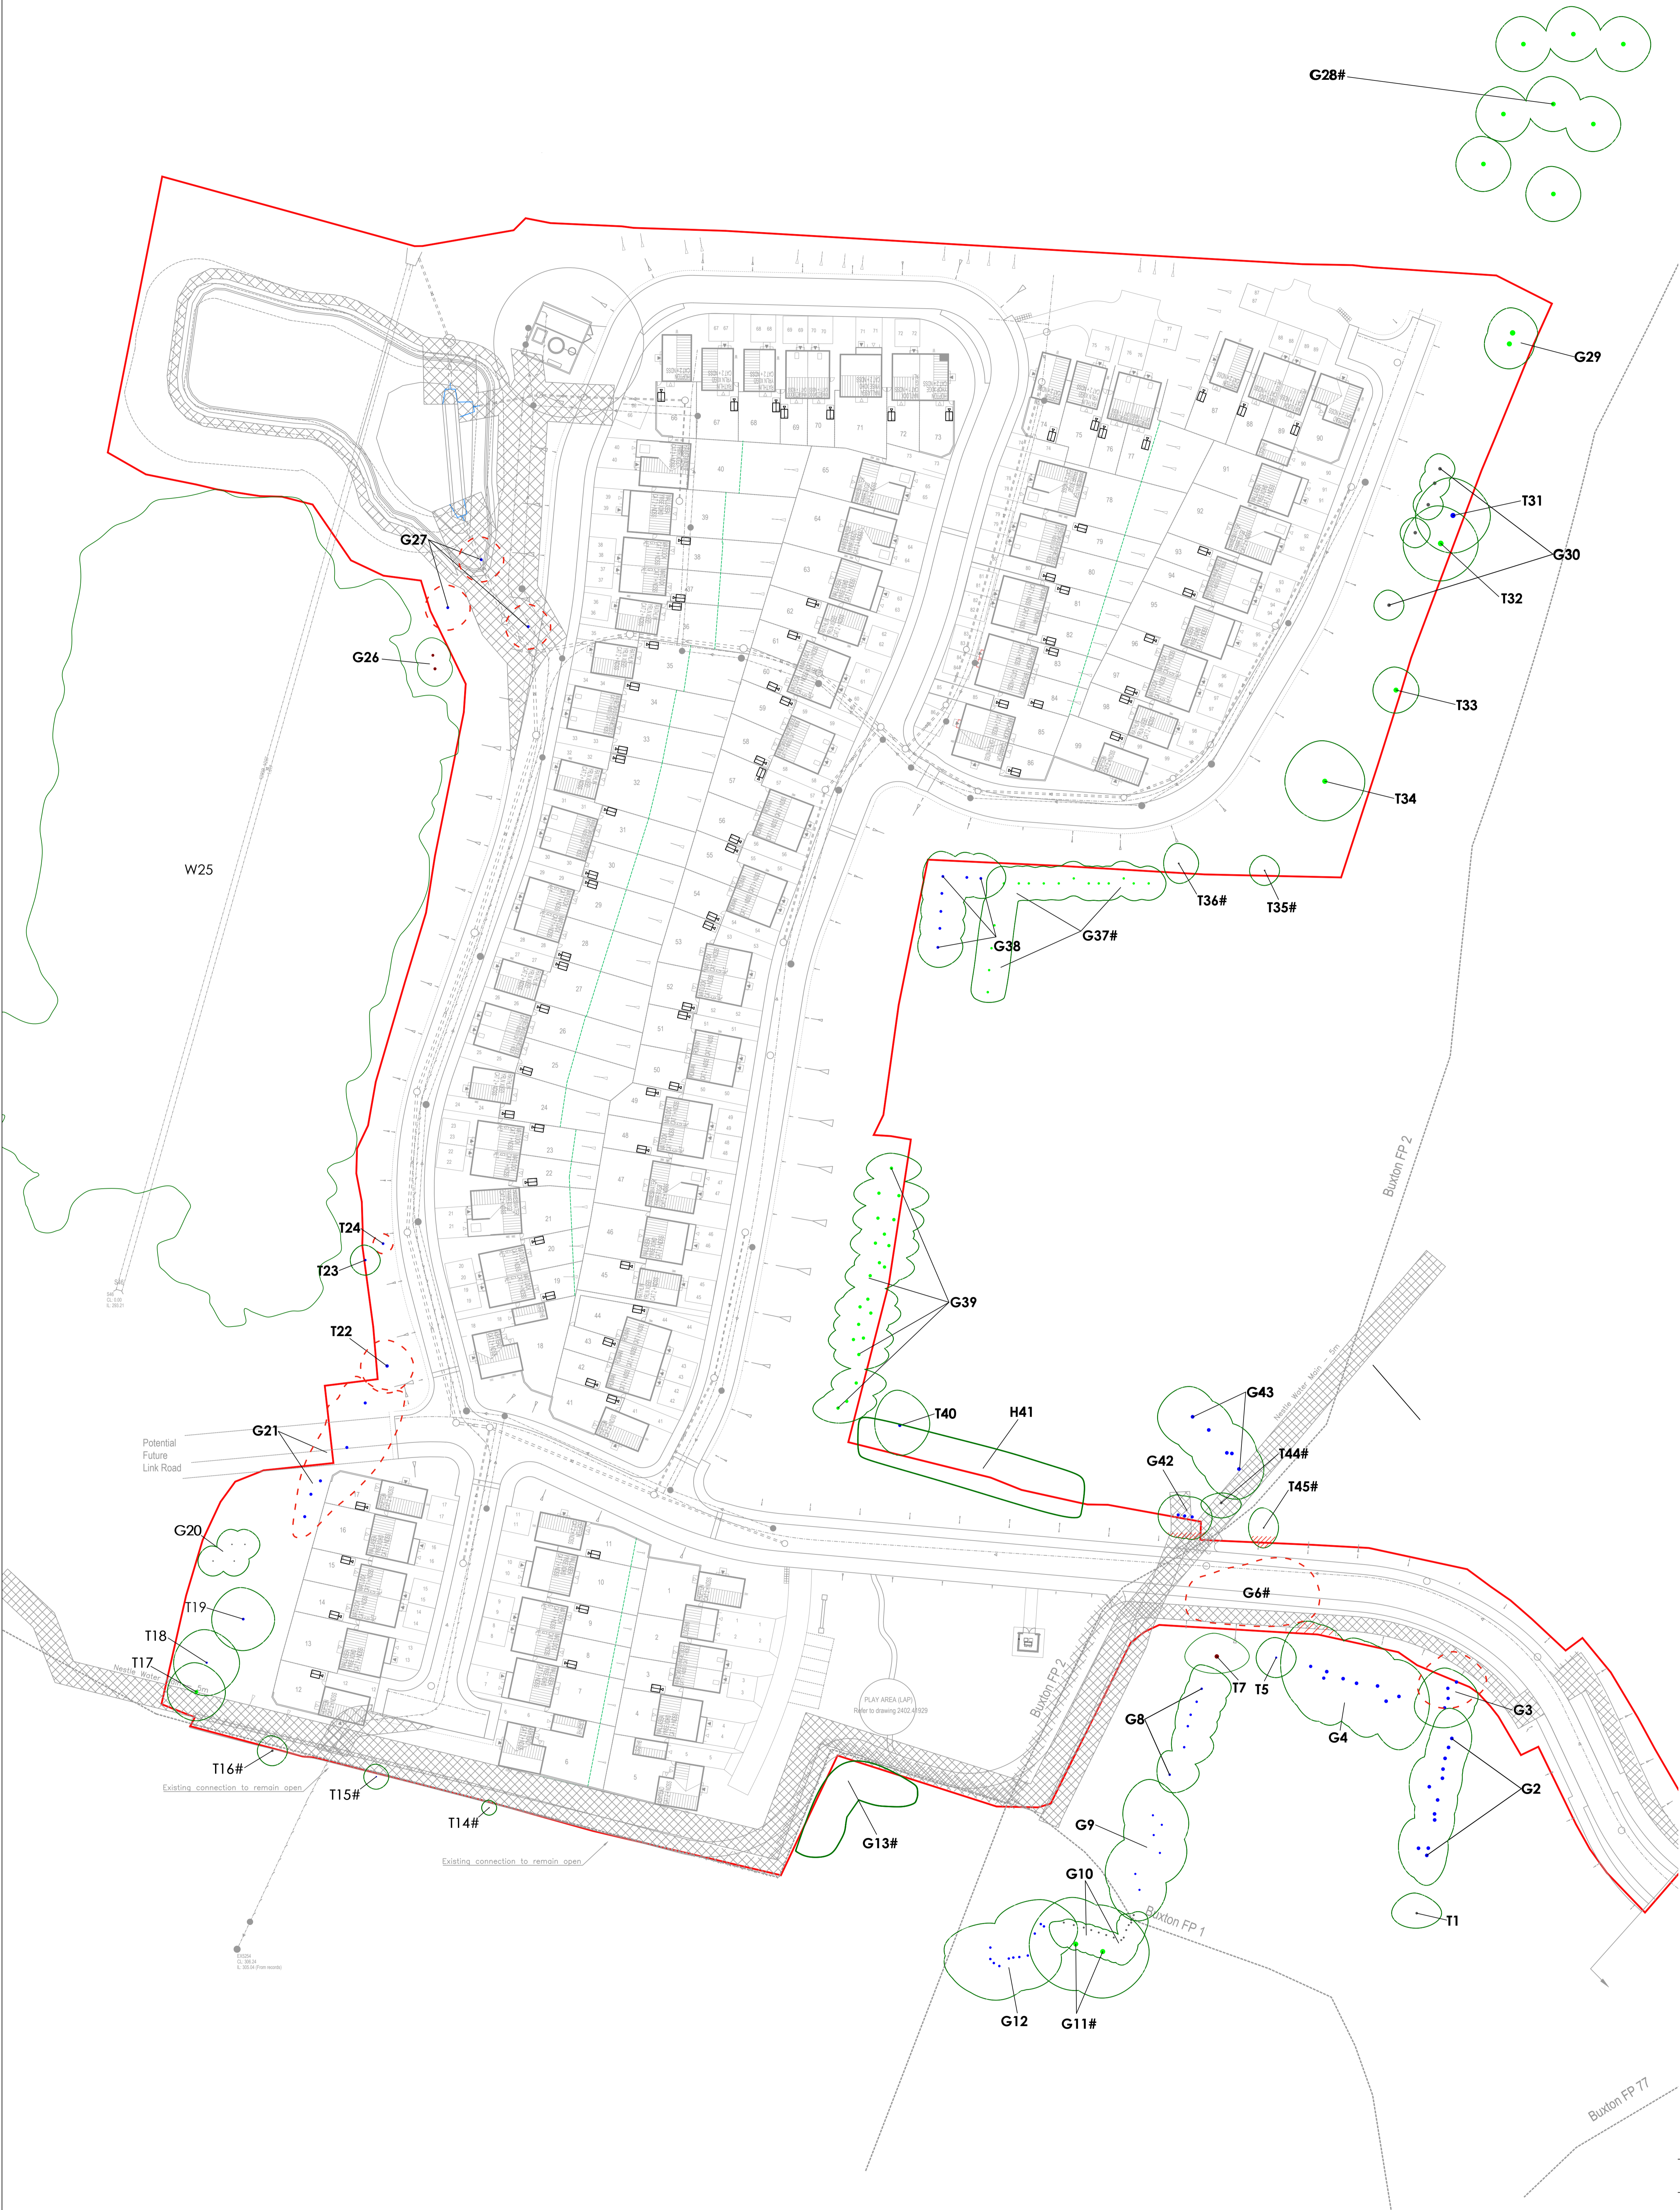
Client:	Project:	Drawn:	Checked:	Approved:	Date:
BARRATT HOMES MANCHESTER	HOGSHAW FARM, FAIRFIELD, BUXTON	AH	RH	GK	24/01/23
Issue:	Title:	Dwg No:	Scale @ A0:	Revision:	
PLANNING	TREE PROTECTION PLAN	UG_1795_ARB_TPP_01	1:500	05

- 1.1.8. Tree protection fencing and ground protection will need to be installed at the alignment shown on the Tree Protection Plan in Appendix 4 before any construction activity takes place.
